State of Washington Department of Ecology
**Cruise Ship Memorandum of
Understanding, Cruise Operations in
Washington State Inspection Report**

Northwest Regional Office

PHOTO ADDENDUM – AMSTERDAM
HOLLAND AMERICA LINE
JULY 29, 2019

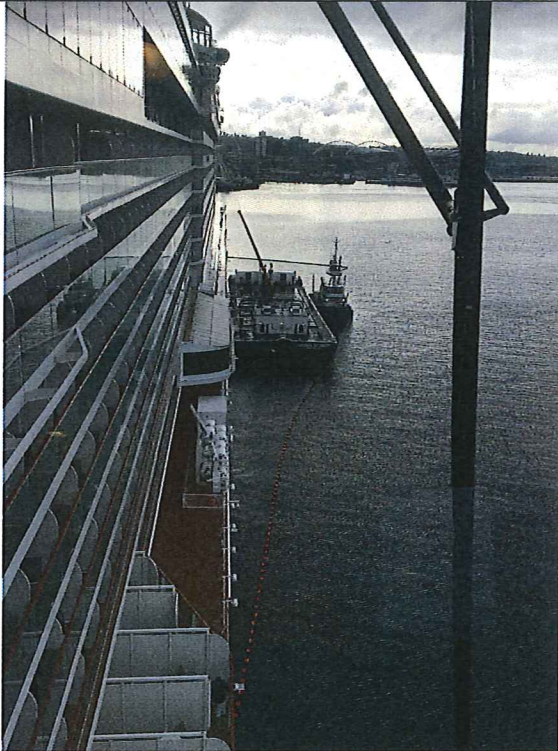
Photo # 3 Image: IMG_0433 Date: 9/28/2019
Taken by: Amy Jankowiak
Description: Bridge – View of bunkering Fuel

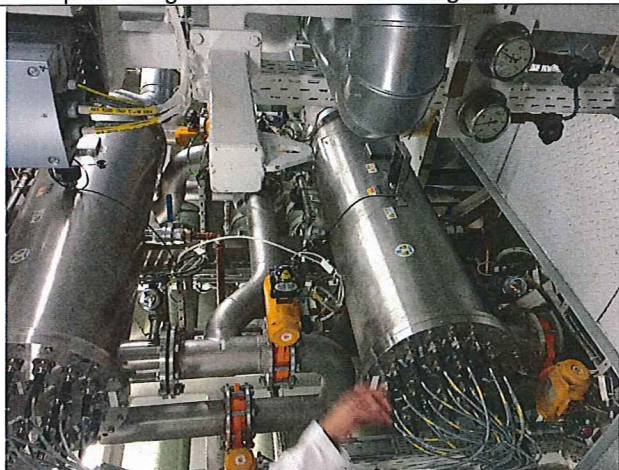
Flow then moves to ultraviolet (UV) light disinfection (photo #11). There are two large UV units, which one can be in standby for cleaning (photo #13). The UV system is alarmed for bulb failure and intensity. Flow from the UV units is either discharged directly overboard via the discharge port (if in an area of allowed discharge) or is re-circulated to the mixing tanks (photo #12).

Photo # 11 Image: IMG_0436 Date: 9/28/2019
Taken by: Amy Jankowiak
Description: Scanship UV

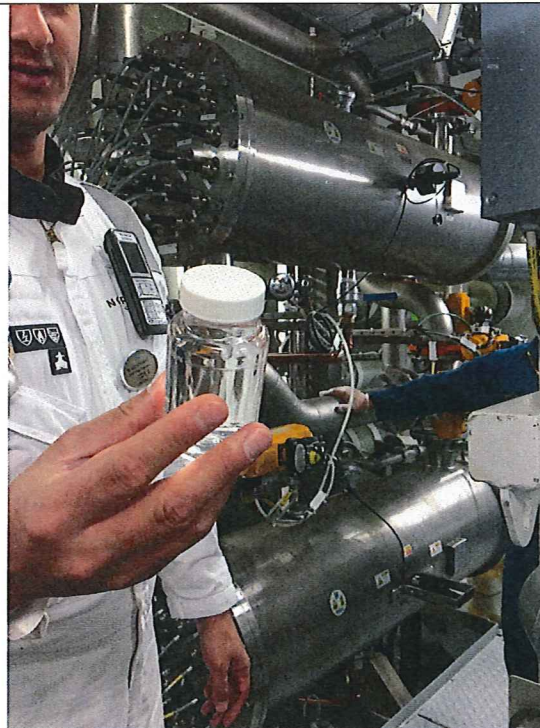
Photo # 12 Image: IMG_0437 Date: 9/28/2019
Taken by: Amy Jankowiak
Description: Scanship effluent sample

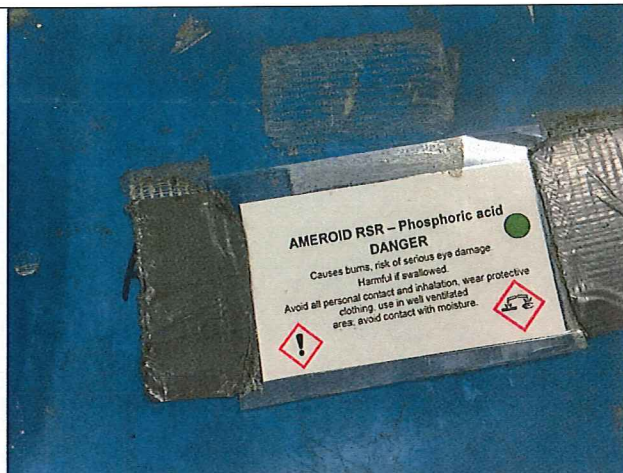
Photo # 13 Image: IMG_2145 Date: 9/28/2019
Taken by: Evan Dobrowski
Description: Scanship UV cleaner chemical

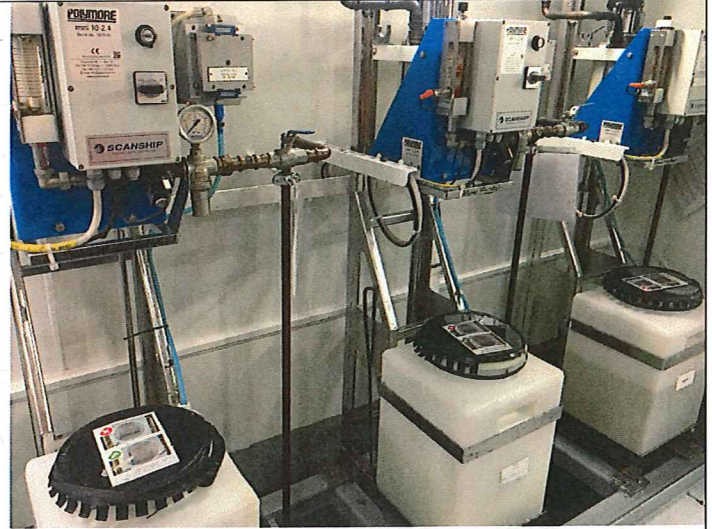
After the biostep, polymers (photo #17) and coagulants are added (photo #18). Liquid then moves to the Dissolved Air Flotation (DAF) tanks for clarification. An air and water mixture is added to the bottom of the flotation tanks to keep turbulence at the bottom and to allow the solids to rise to the top, along with the help of the chemical addition. Skimmers on the top skim the solids into a sludge pocket which is then pumped to the bioresidue tank which is discharged outside of MOU related waters and more than 12 miles. Liquid flow then moves to the polishing filters (photos #15 and #16) for ultrafiltration.

Photo # 18 Image: IMG_2160 Date: 9/28/2019
 Taken by: Evan Dobrowski
 Description: Scanship Coagulant and Polymer dosing

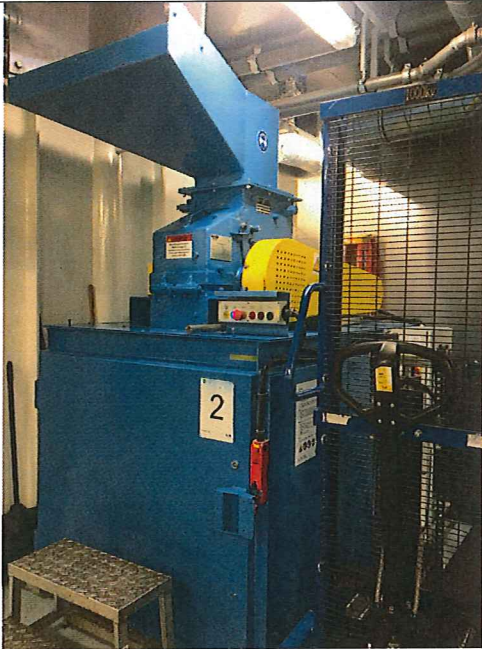
Photo # 21 Image: IMG_0440 Date: 9/28/2019
Taken by: Amy Jankowiak
Description: GR – Glass Crusher

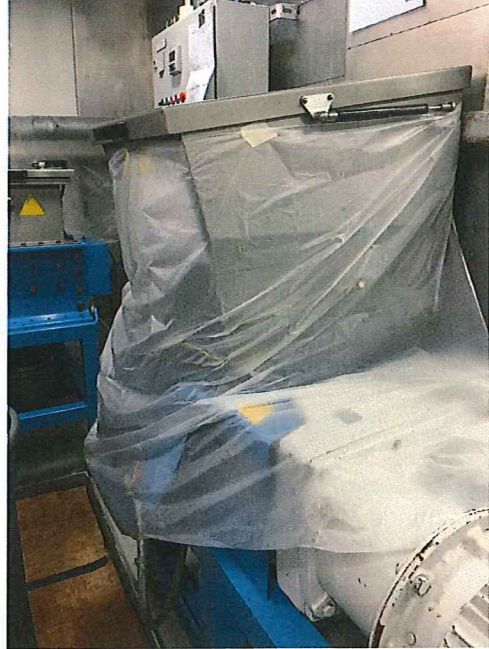
Photo # 22 Image: IMG_0441 Date: 9/28/2019
Taken by: Amy Jankowiak
Description: GR – Food Waste Shredder/Chute

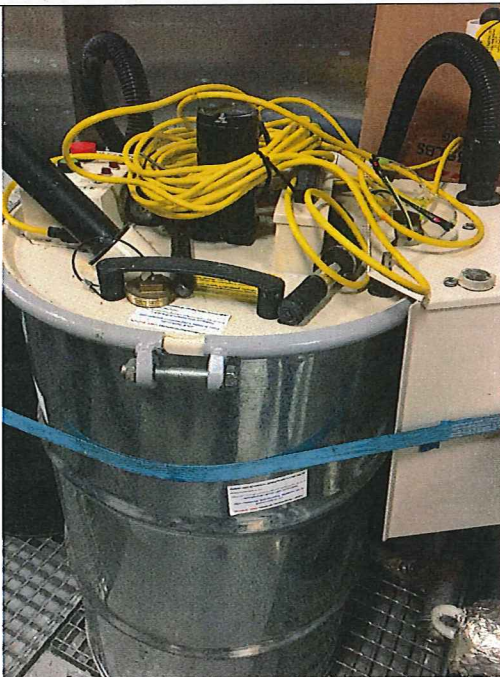
Photo # 23 Image: IMG_0442 Date: 9/28/2019
Taken by: Amy Jankowiak
Description: GR – Hazardous Waste Stor – Bulb Crusher

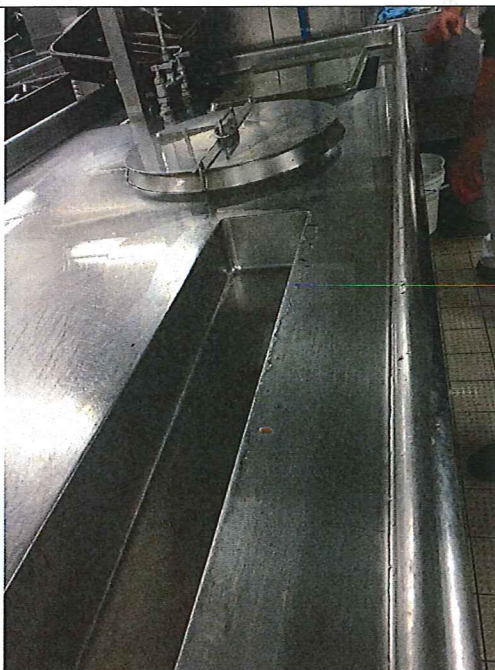
Photo # 27 Image: IMG_0447 Date: 9/28/2019
Taken by: Amy Jankowiak
Description: Galley - Pulper

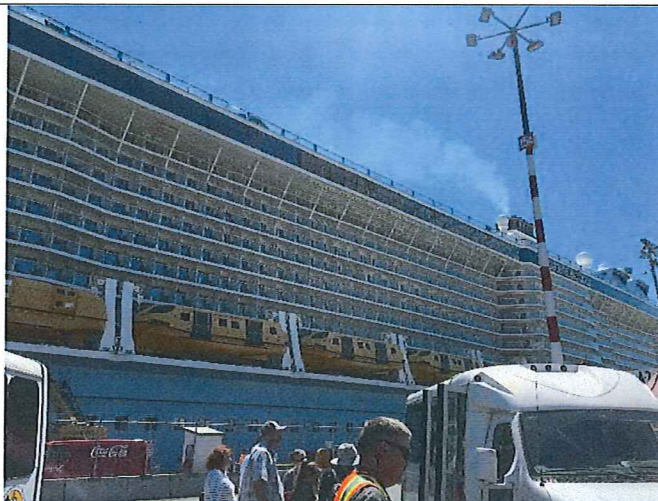
Photo # 1 Image: IMG_0345 Date: 7/26/2019
Taken by: Amy Jankowiak
Description: Vessel

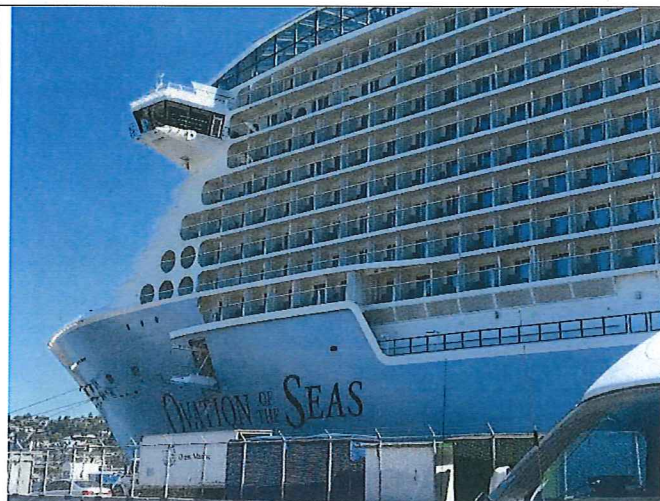
Photo # 2 Image: IMG_0346 Date: 7/26/2019
Taken by: Amy Jankowiak
Description: Vessel

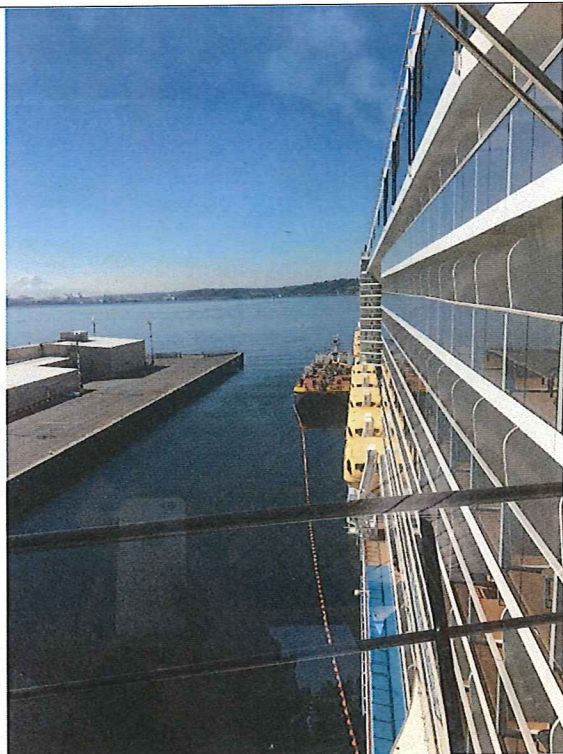
Photo # 5 Image: IMG_0297 Date: 7/26/2019
 Taken by: Amy Jankowiak
 Description: Bridge – View of fuel bunkering

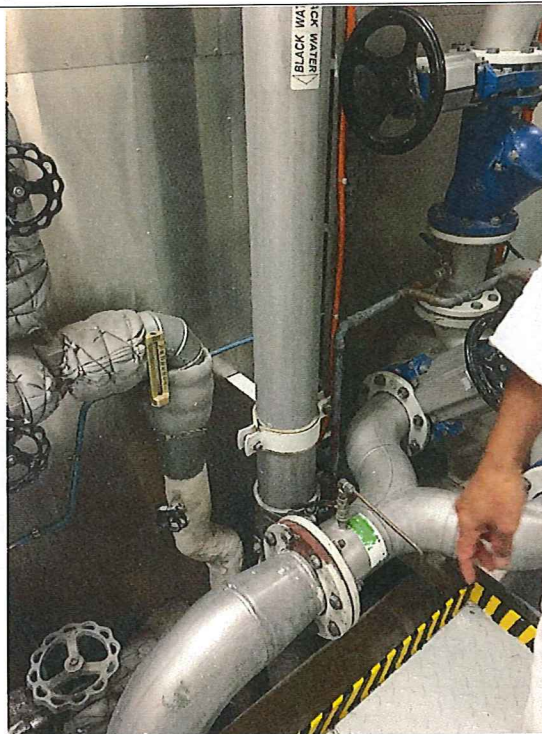
Photo # 14 Image: IMG_0311 Date: 7/26/2019
 Taken by: Amy Jankowiak
 Description: AWP – Pump for mixing tank to biostep

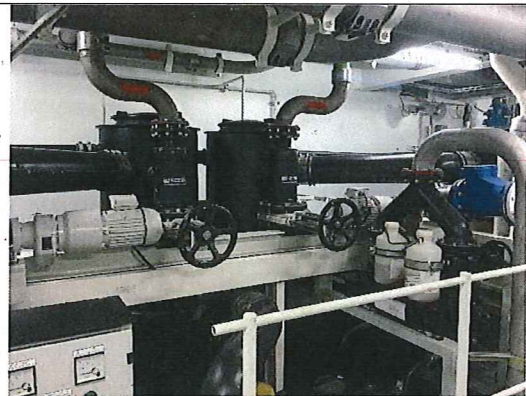
Food waste is sent from the galleys to food waste holding tanks. From there, the food waste goes through a pulper – food press (photo #20). The liquid from the pulper goes to the graywater mixing tanks and the AWP. The food goes to a biowaste dryer and incineration. Any food waste that can't be pulped is incinerated. A grease separator collects grease from the galleys and is combined with used cooking oil for on-shore recycling. Food waste discharges are logged in the NAPA system.

Photo # 20 Image: IMG_0319 Date: 7/26/2019
Taken by: Amy Jankowiak
Description: Food Waste System

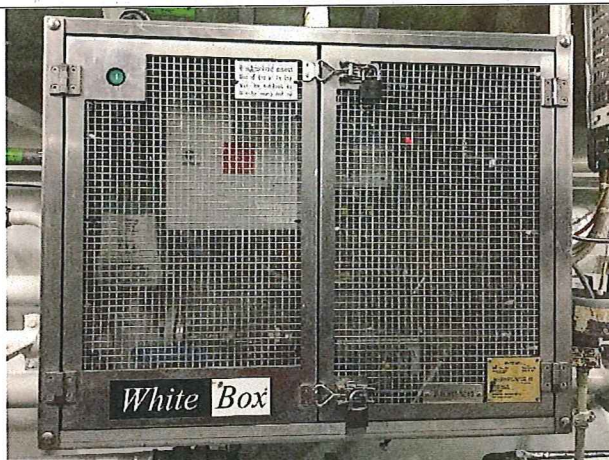
Photo # 23 Image: IMG_0324 Date: 7/26/2019
Taken by: Amy Jankowiak
Description: Clean Bilge White Box

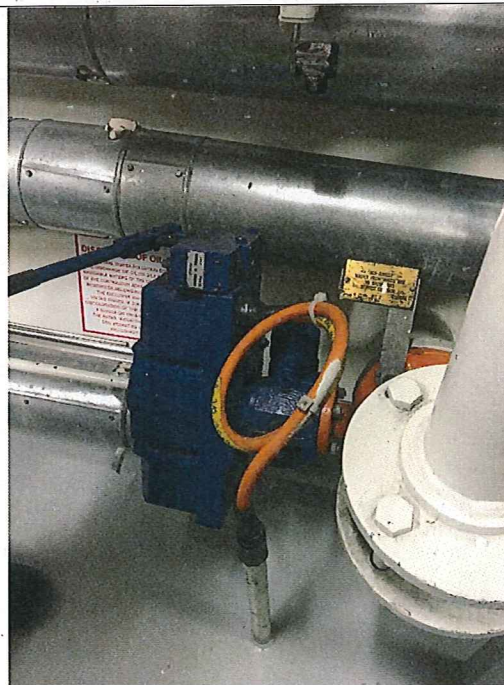
Photo # 24 Image: IMG_0326 Date: 7/26/2019
Taken by: Amy Jankowiak
Description: Clean Bilge Overboard Discharge Port

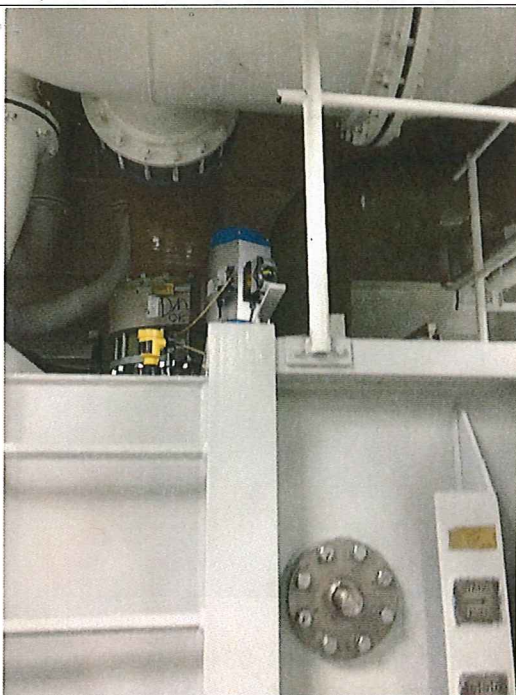
Photo # 27 Image: IMG_0330 Date: 7/26/2019
 Taken by: Amy Jankowiak
 Description: EGCS – Dirty Water Process Tank from Stack

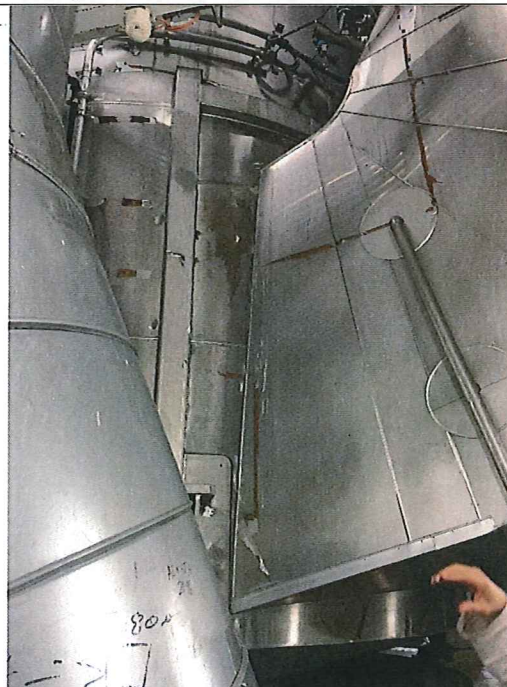
Photo # 28 Image: IMG_0332 Date: 7/26/2019
 Taken by: Amy Jankowiak
 Description: EGCS – Tower and water spray inside (down angle)

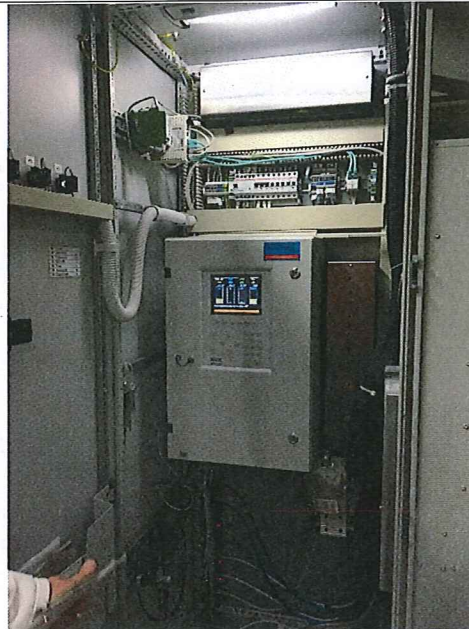
Photo # 30 Image: IMG_0335 Date: 7/26/2019
 Taken by: Amy Jankowiak
 Description: EGCS – Continuous Monitoring System

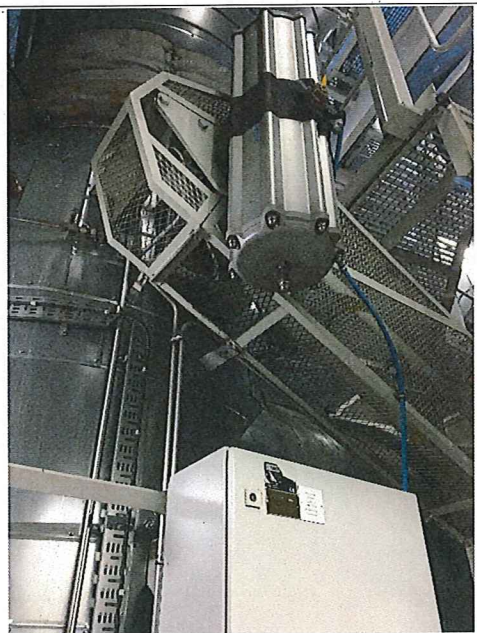
Photo # 31 Image: IMG_0336 Date: 7/26/2019
 Taken by: Amy Jankowiak
 Description: EGCS - Damper

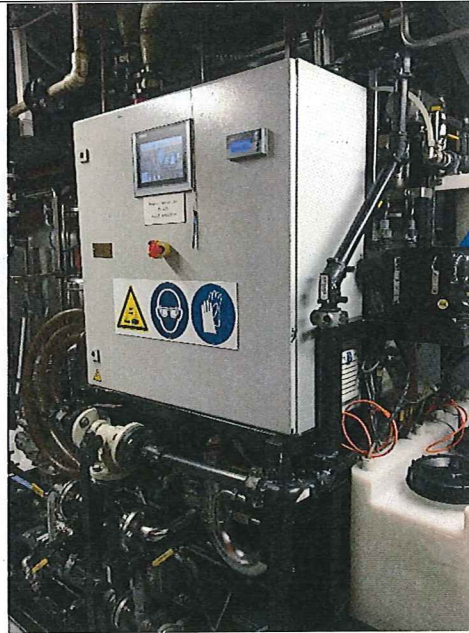
Photo # 32 Image: IMG_0340 Date: 7/26/2019
 Taken by: Amy Jankowiak
 Description: EGCS – Bleed-off Treatment Unit

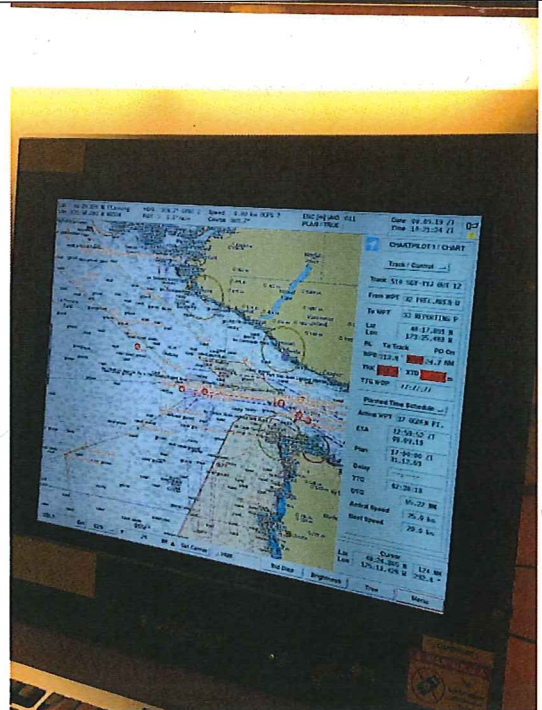
Photo # 4 Image: IMG_0391 Date: 9/8/2019
Taken by: Amy Jankowiak
Description: Bridge – Navigation – entry to Strait of Juan de Fuca near Olympic Coast National Marine Sanctuary

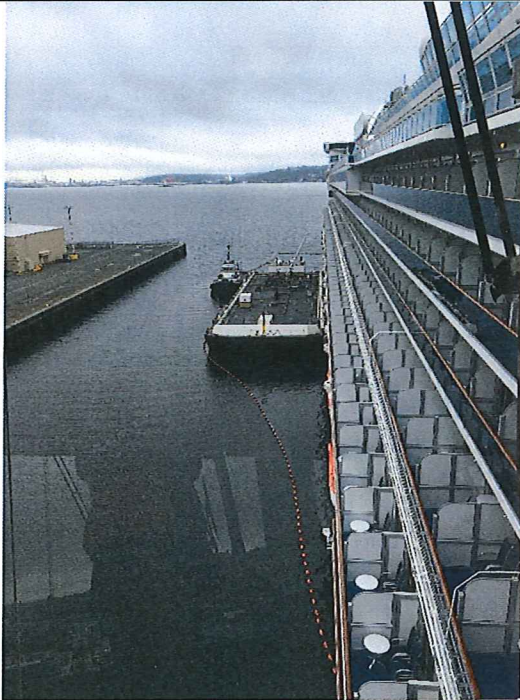
Photo # 5 Image: IMG_0393 Date: 9/8/2019
 Taken by: Amy Jankowiak
 Description: Bridge – view of fuel bunkering

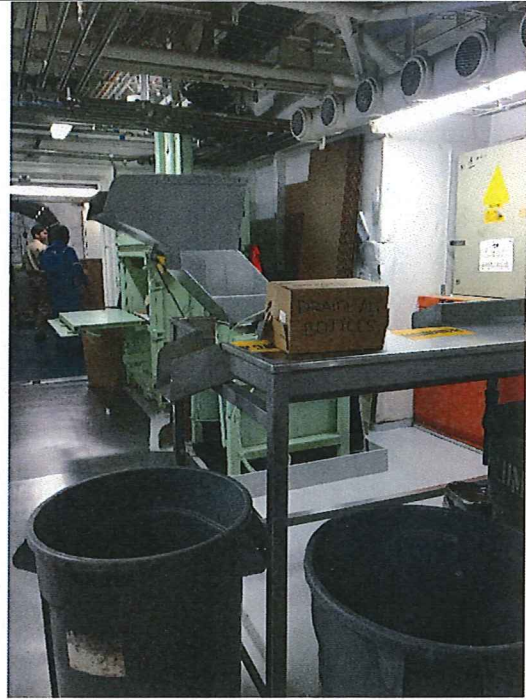
Photo # 6 Image: IMG_0394 Date: 9/8/2019
 Taken by: Amy Jankowiak
 Description: Recycling Room (RR) – sorting and compacting

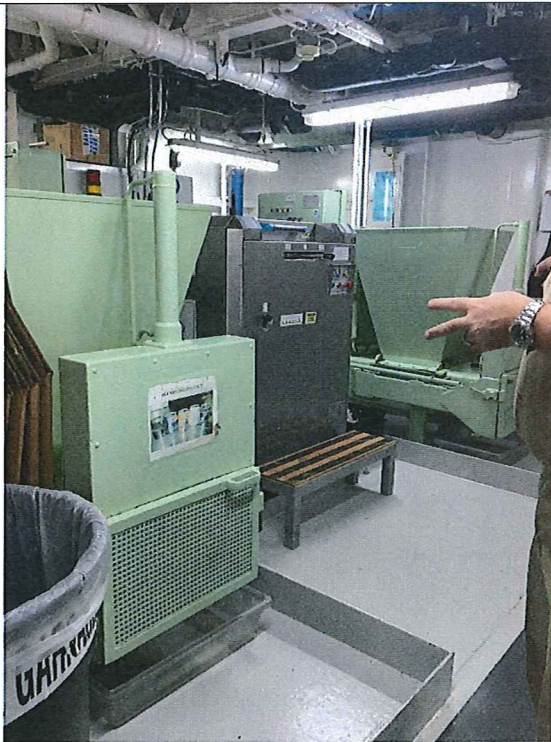
Photo # 7 Image: IMG_0395 Date: 9/8/2019
 Taken by: Amy Jankowiak
 Description: RR – aluminum crushing (green) and plastic compactor (silver)

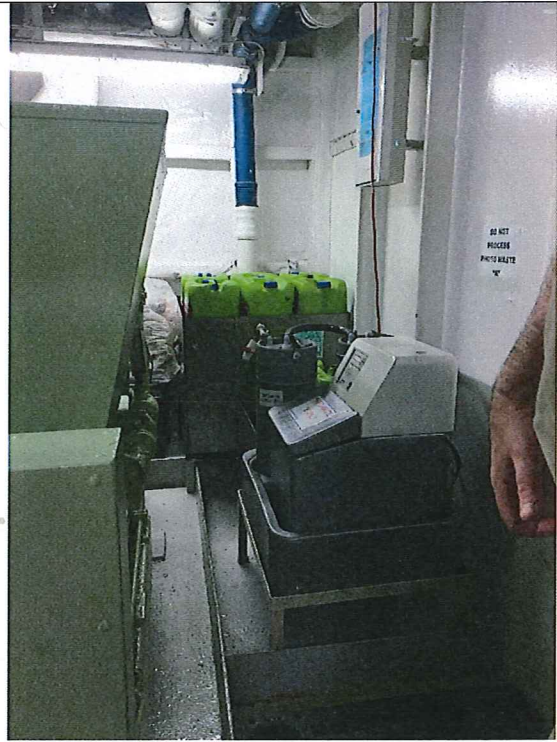
Photo waste (photo #08) goes through a silver recovery unit with offloads in Victoria when silver is less than 5 ppm. Tests are logged and kept. X-rays are done digitally without any waste. Fluorescent bulbs are stored until offloading as hazardous waste. Hazardous waste materials are stored separately (photo #14) and offloaded only in Victoria on this route. Solid waste (garbage, recyclables, etc) is collected, sorted (photo #06), and either reused, recycled, incinerated or off-loaded to shore as appropriate. Glass (photo #09) and aluminum are crushed and plastics are compacted (photo #07). Waste minimization efforts are done by tracking, material usage analysis, and minimizing materials. All solid waste is offloaded in Victoria on this route.

Photo # 8 Image: IMG_0397 Date: 9/8/2019
 Taken by: Amy Jankowiak
 Description: RR – Photo waste processing

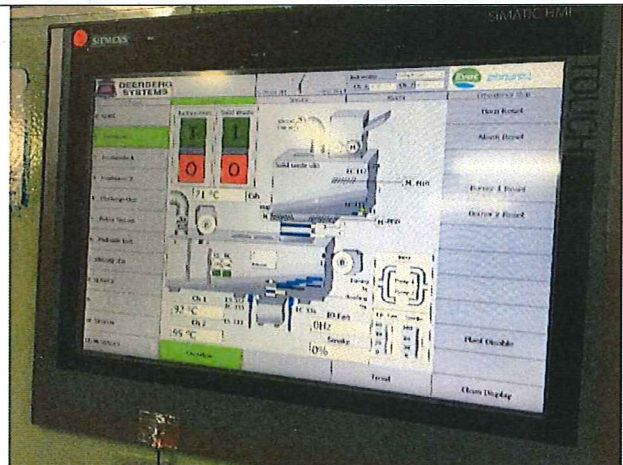
Two Incinerators (photos #15 and #16) are used onboard when one hour outside port and outside the OCNMS. Ash is offloaded in Victoria on this route.

Photo # 16 Image: IMG_0405 Date: 9/8/2019
 Taken by: Amy Jankowiak
 Description: Waste Management – Incinerator Schematic

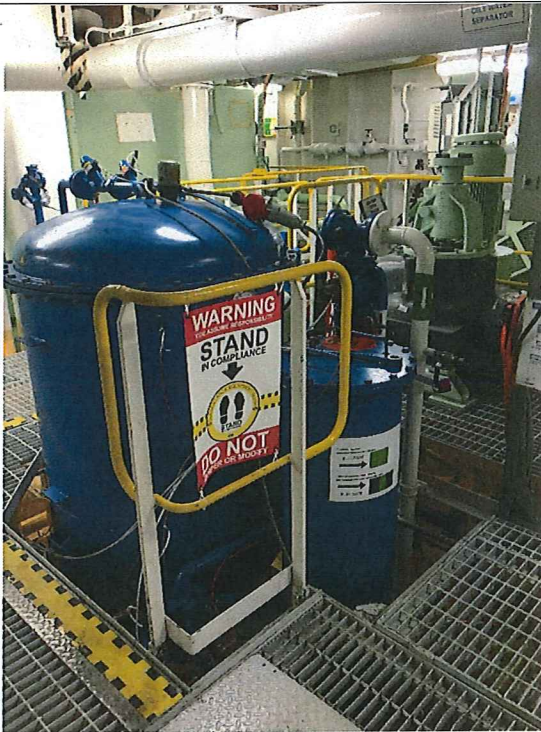
Dirty bilge water collected and is sent to the oily bilge settling tank. Liquid moves to the centrifugal oily water separator (OWS) (photo #18). Treated bilge then goes through the bilge control discharge box (BCDB), also known as the "white box" (photo #19) or to the static OWS (photo #17) and then the liquid goes to the white box. The white box's three-way valve sends treated bilge at less than 15 ppm overboard in areas where allowed or recirculates back for treatment. The oily sludge is collected to a sludge box, drummed and offloaded in Victoria on this route. Discharges of clean bilge and offloads of oily sludge are recorded in the Oil record Book. The overboard discharge port is padlocked (photo #20). All bilge equipment is labeled to prevent tampering and the area is monitored and video recorded. All seals, padlocks, fittings and portable pumps are inventoried and checked out for use. If other tanks such as grey water overflow and contact with any bilge, it is then considered bilge and treated as bilge or offloaded. Any such overflow is to be reported to the EO and an incident report is filed with the company. The EO and Engineer confirmed that they are not aware of any rerouting of oily bilge. Staff have multiple ways of reporting any issues to upper staff, the cruise line, corporate and anonymously. Oil volumes are compared of incoming, used, and discharged or offloaded regularly.

Photo # 17 Image: IMG_0425 Date: 9/8/2019
 Taken by: Amy Jankowiak
 Description: Bilge – Static Oily Water Separator (OWS)

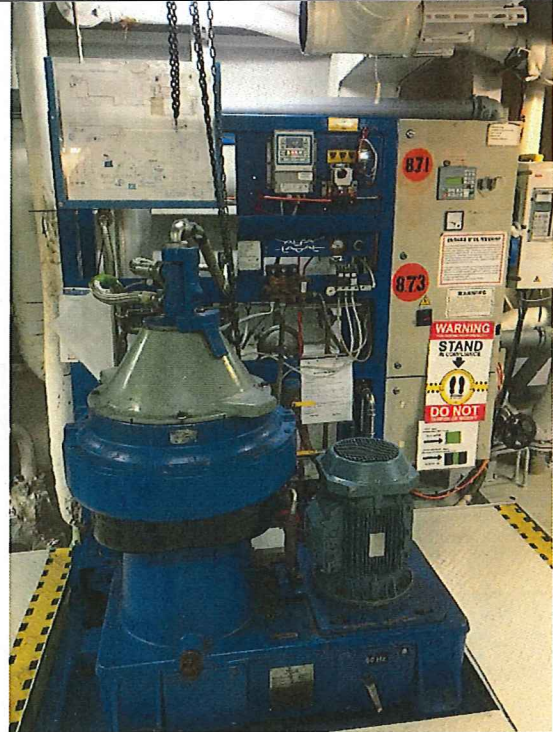
Photo # 18 Image: IMG_0427 Date: 9/8/2019
 Taken by: Amy Jankowiak
 Description: Bilge – Centrifugal OWS

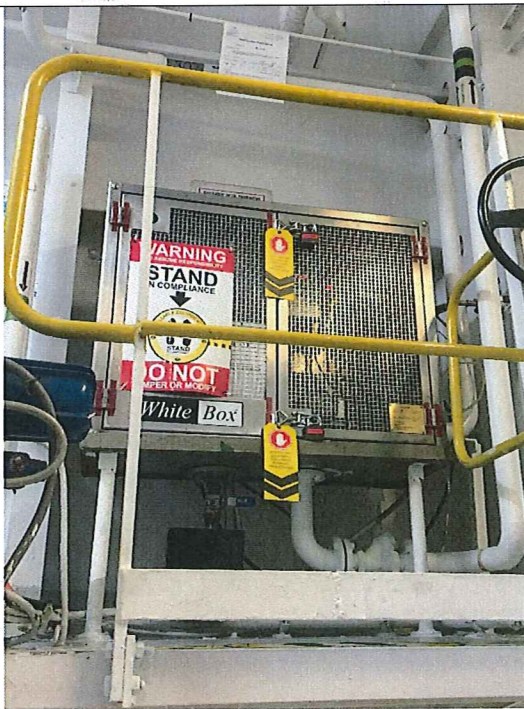
Photo # 19 Image: IMG_0410 Date: 9/8/2019
 Taken by: Amy Jankowiak
 Description: Bilge – White Box

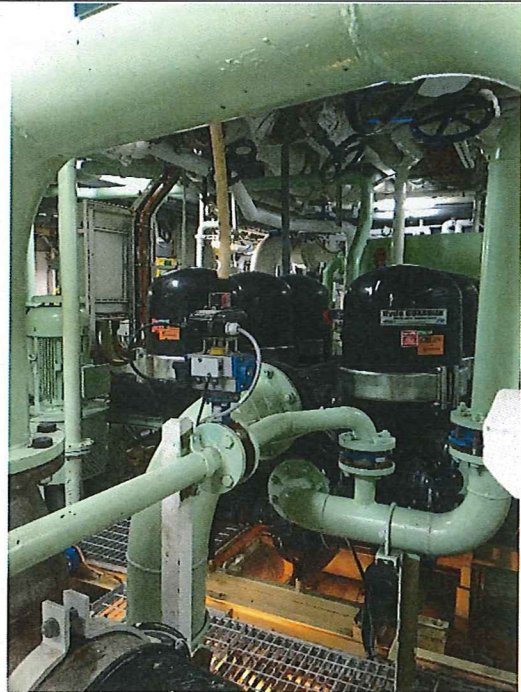
When necessary, ballast water is treated on board with a filter and ultraviolet light disinfection system (photo #22). Most of the time, ballast is handled with on-board holding, and only on the rare occasions that an exchange might occur, the ballast treatment system is used. The vessel has just recently received a newly updated ballast treatment system (photo #21) that will replace the current one.

Photo # 22 Image: IMG_0423 Date: 9/8/2019
Taken by: Amy Jankowiak
Description: Existing Ballast Water Treatment System

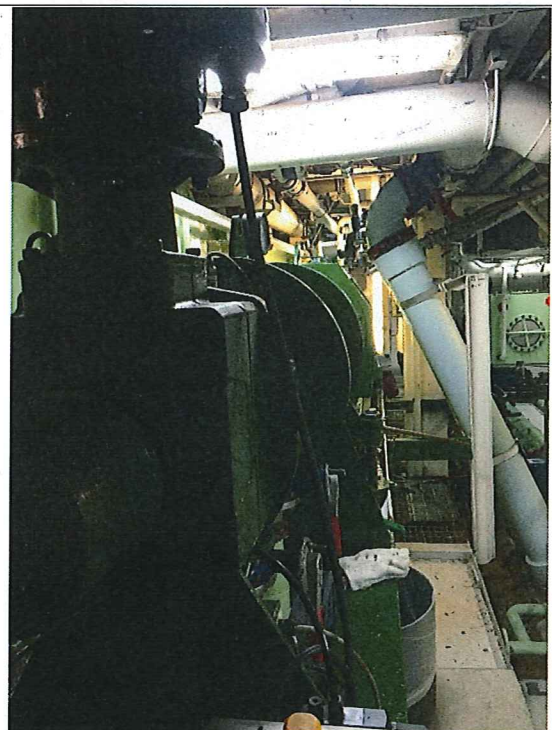
MBR's operation: Grey water or black water is fed to MBR's. The first phase of the process is the Screen Press (photo #24) which filters paper and other solids (screenings) out of the waste stream. The screenings are collected (photo #25) and transported for disposal by incineration. The feed then flows into the first stage of the Bio-reactor (photo #26) which operates as an aerobic biological treatment system. Flow is then transferred from the first stage to the second via the Interstage Filter System (photo #27). Solids from the system are discharged outside of MOU related waters. The clean filtrate is treated through the membranes (photo #28) via high pressure. The final effluent from all membranes is sent

Photo # 24 Image: IMG_0418 Date: 9/8/2019
Taken by: Amy Jankowiak
Description: Hamworthy – Screen Press

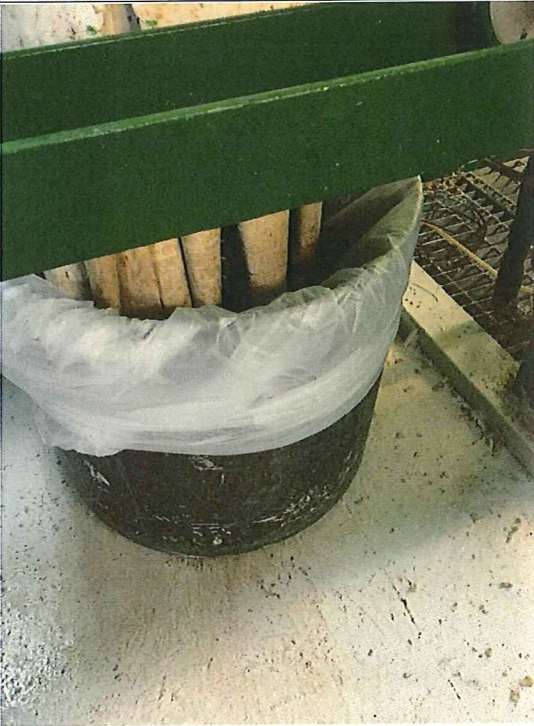
Photo # 25 Image: IMG_0419 Date: 9/8/2019
Taken by: Amy Jankowiak
Description: Hamworthy – screen press solids for incineration

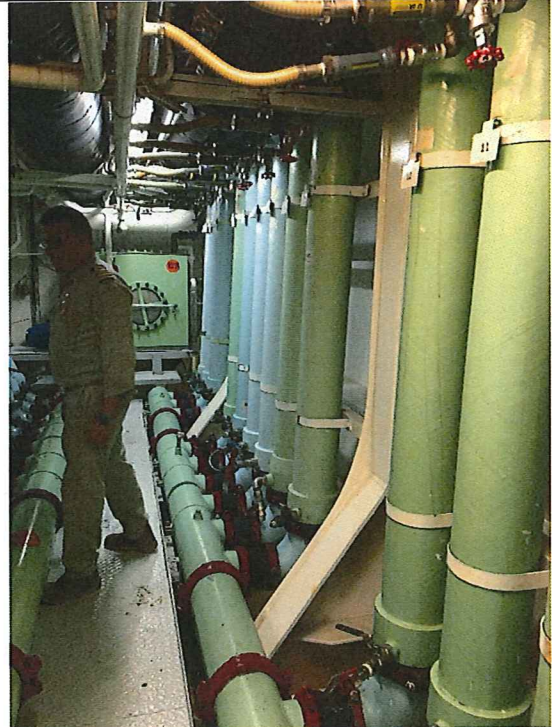
Photo # 28 Image: IMG_0421 Date: 9/8/2019
Taken by: Amy Jankowiak
Description: Hamworthy – Membrane filters

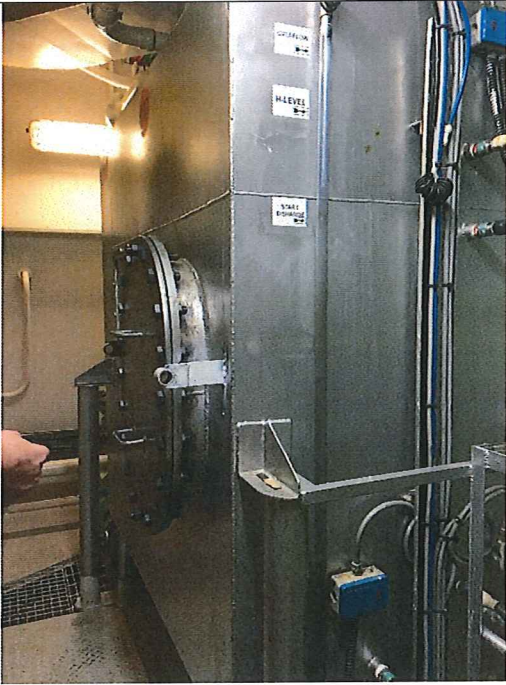
The effluent from the MBR's in operation is pumped overboard through a permeate tank (photo #29) outside of the MOU related waters or held into double bottom holding tanks. Some graywater on this vessel is held untreated and discharged outside of MOU related waters.

Photo # 29 Image: IMG_0413 Date: 9/8/2019
 Taken by: Amy Jankowiak
 Description: Hamworthy - permeate
